Firm Foundation Home Inspection LLC

Home Inspection Report

Horton Way

Lewisburg, TN 37091

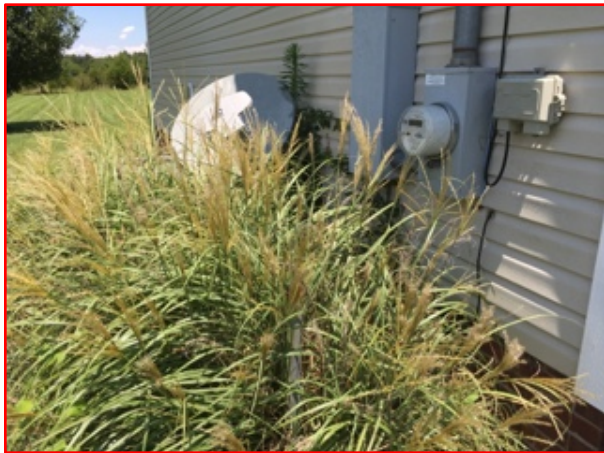
Figure 1-1

- 1) Access to main panel blocked by vegetation.

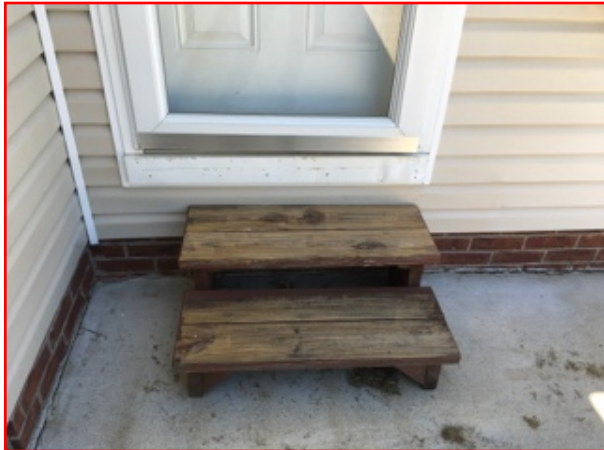
Figure 2-1

- 2) Back porch steps were differing in height. Steps were not attached to the concrete or the house. Railing was present but not useful at steps.

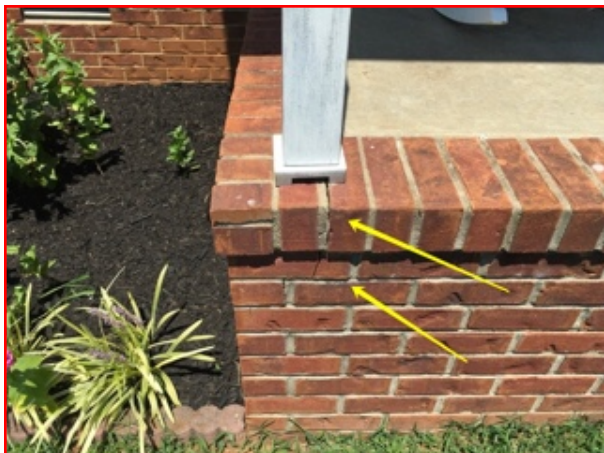
Figure 3-1

3) Brick veneer of porch has settled and cracked. Recommend tuck-pointing mortar joints to prevent water entry and a freeze thaw condition. Monitor bricks for further settling.

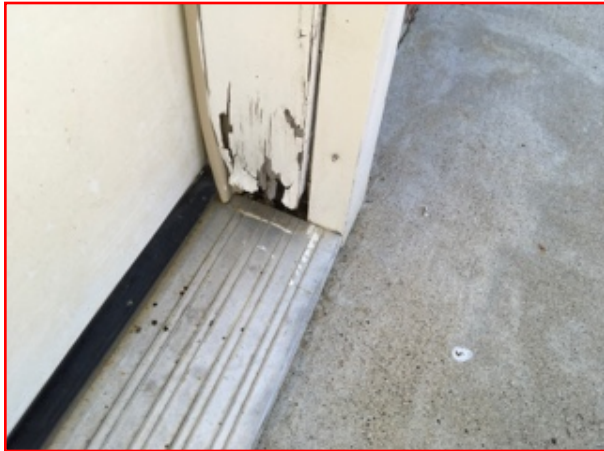
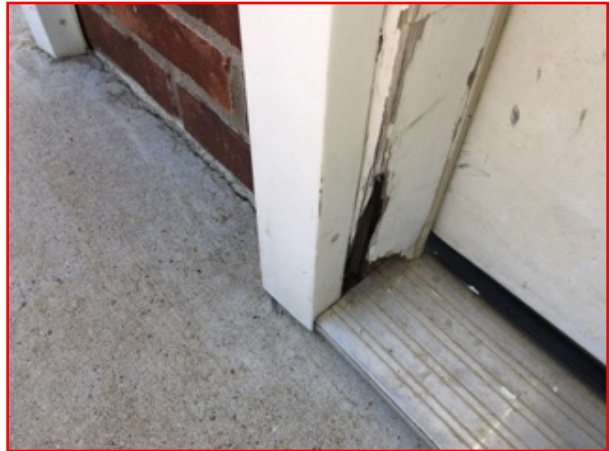
4) Door jambs at garage entry shows signs of dry rot.

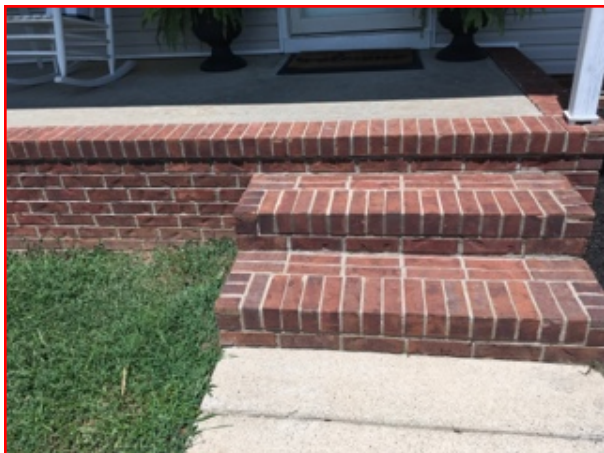
Figure 5-1

5) Codes recommends anything greater than 2 steps have a handrail.

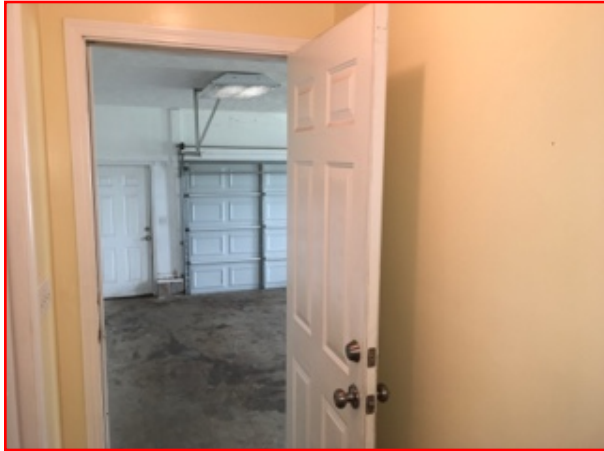
Figure 6-1

6) Current codes calls for a fire rated door and self closing hinges on door leading to garage.

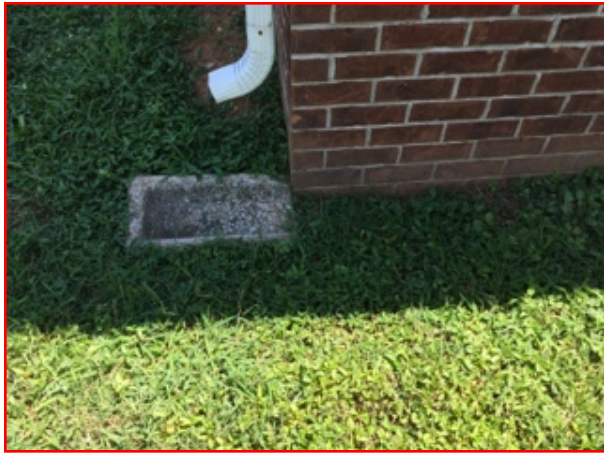
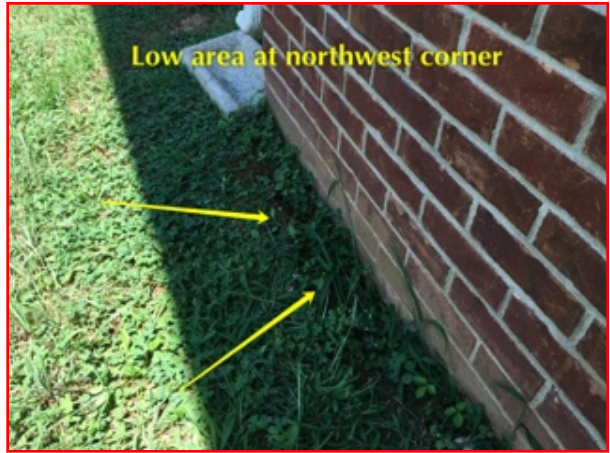
7) Recommend downspout extension to move water away from foundation.

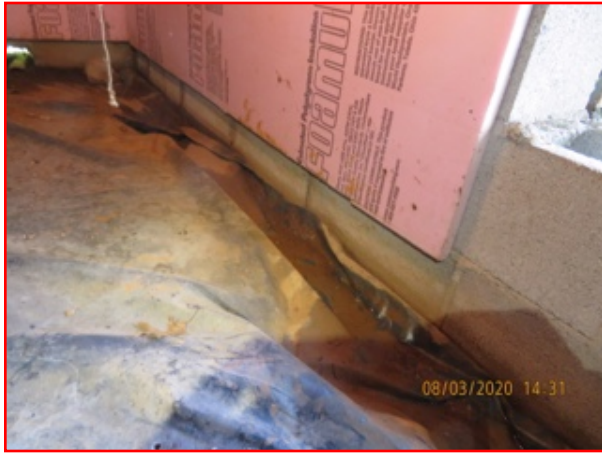
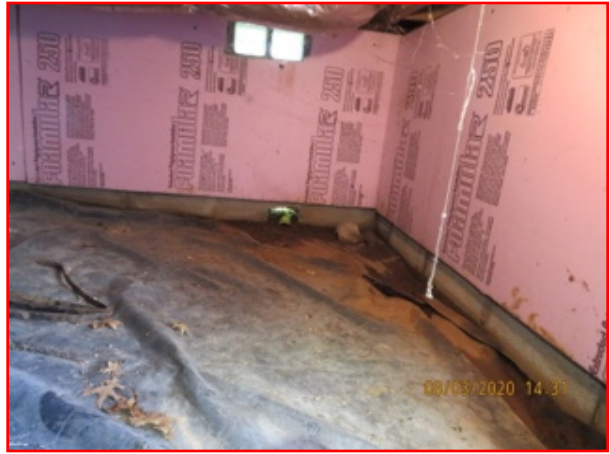
8) Crawlspace wet at access. Pictures in "Site" will show areas here that need grade work.

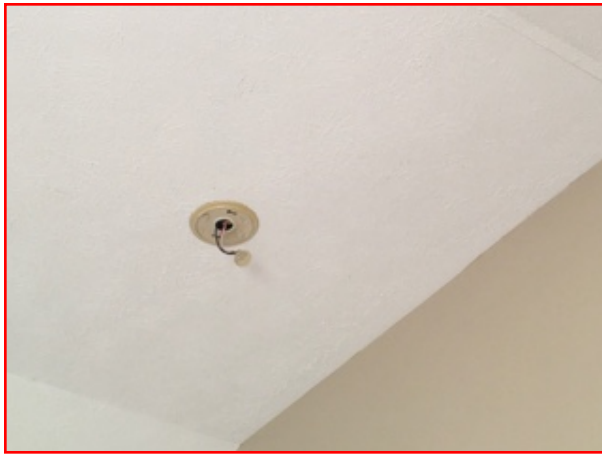
Figure 9-1

9) Living area smoke detector missing.

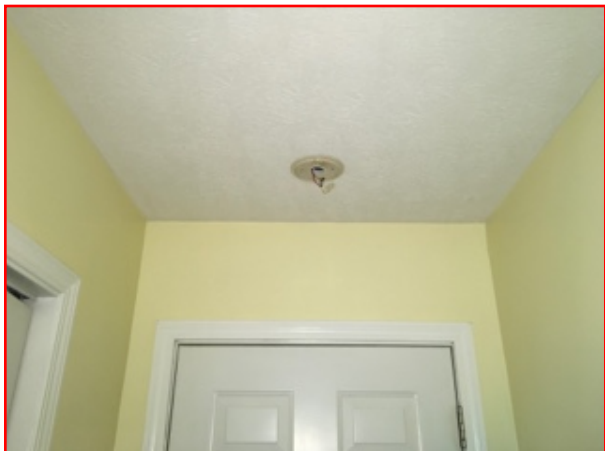
Figure 10-1

10) Smoke detector missing in kitchen hall.

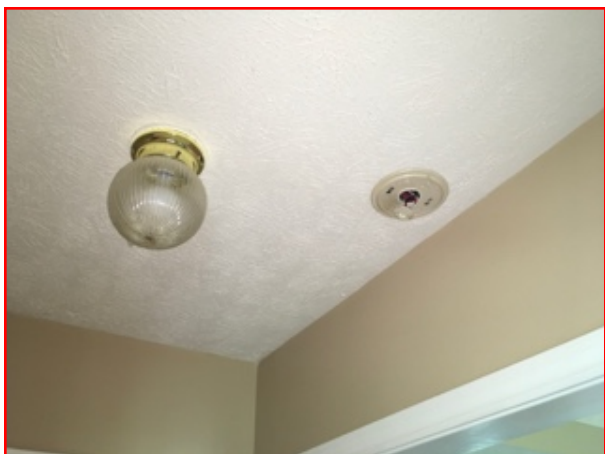
Figure 11-1

11) Missing smoke detector hall at guest bath.

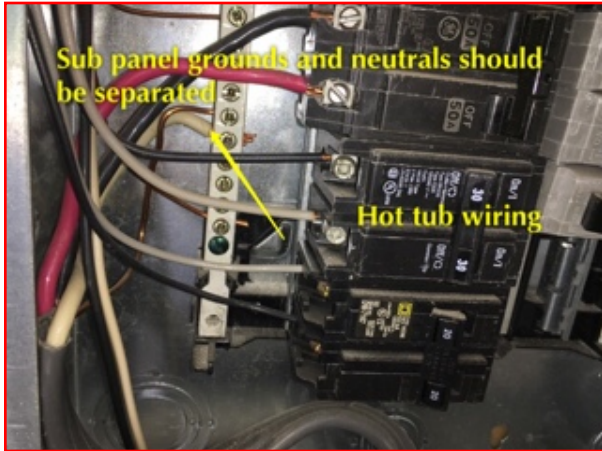
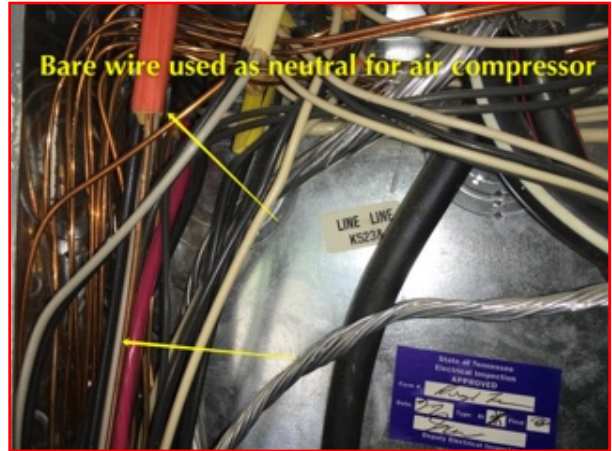
12) NEC calls for neutrals and grounds be isolated from one another in a sub panel.

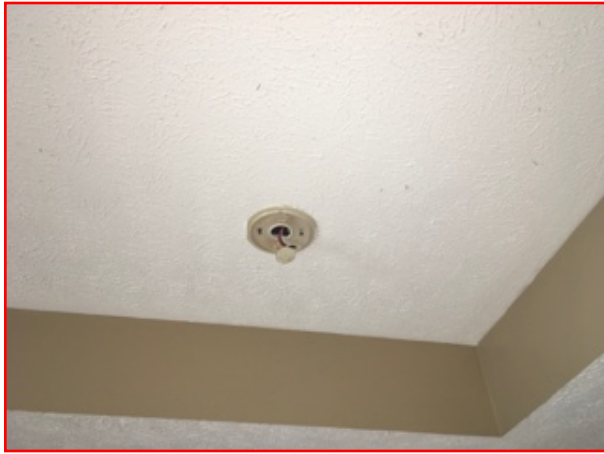
Figure 18-1

15) Missing smoke detector.

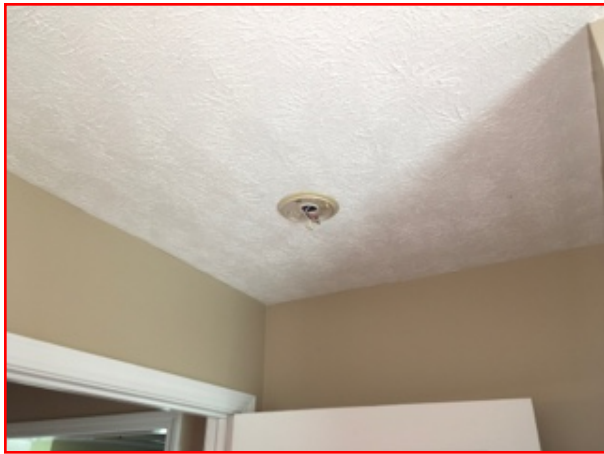
Figure 19-1

16) Missing smoke detector .

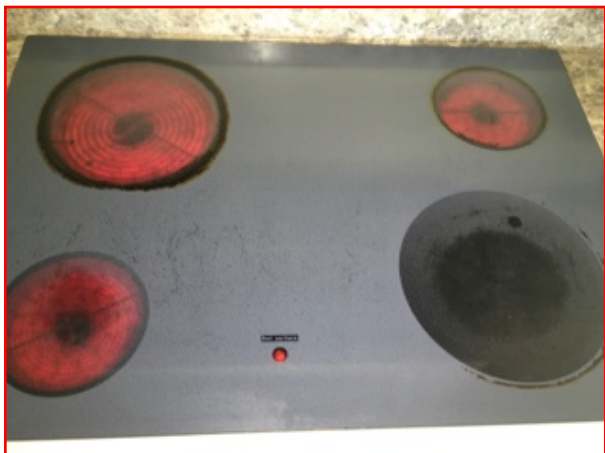
Figure 20-1

17) Front right eye not operating on cook top.

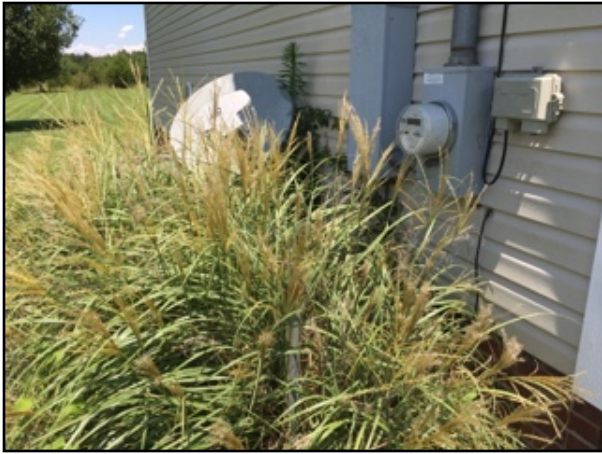
Figure 1-1

Comment 1:
Access to main panel blocked by vegetation.

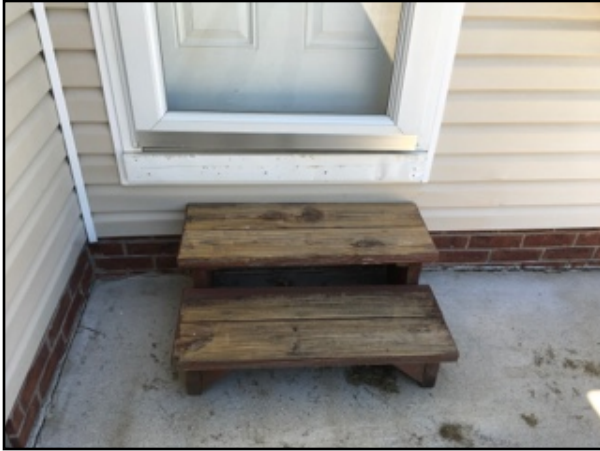
Figure 2-1

Comment 2:
Back porch steps were differing in height. Steps were not attached to the concrete or the house. Railing was present but not useful at steps.

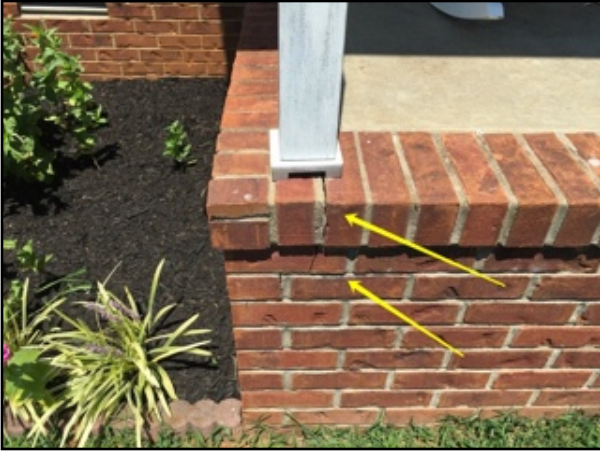
Figure 3-1

Comment 3:
Brick veneer of porch has settled and cracked. Recommend tuck-pointing mortar joints to prevent water entry and a freeze thaw condition. Monitor bricks for further settling.

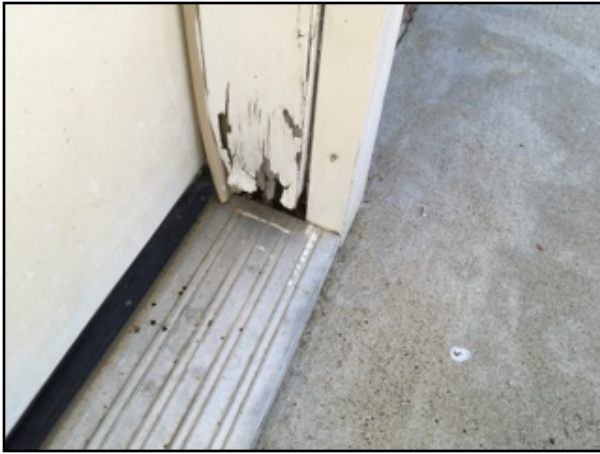
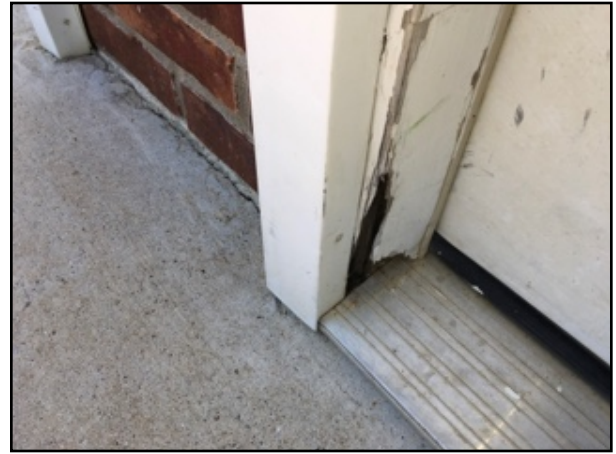
Comment 4:
Door jambs at garage entry shows signs of dry rot.

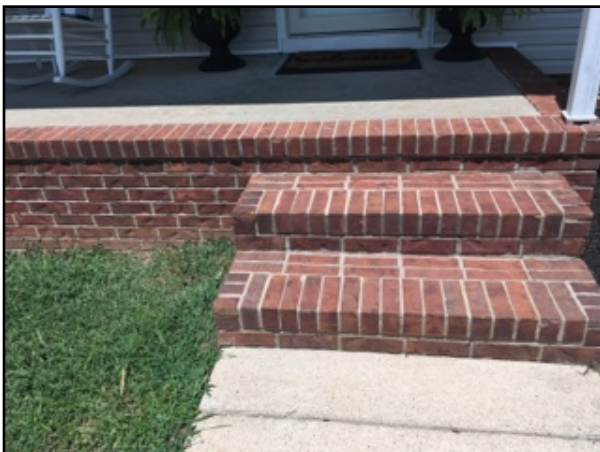
Figure 5-1

Comment 5:
Codes recommends anything greater than 2 steps have a handrail.

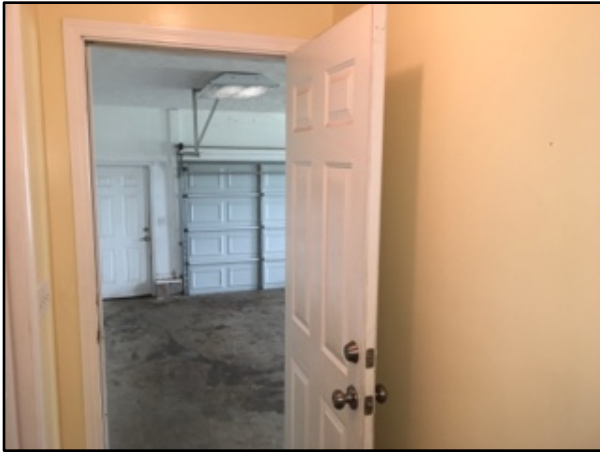
Figure 6-1

Current codes calls for a fire rated door and self closing hinges on door leading to garage.

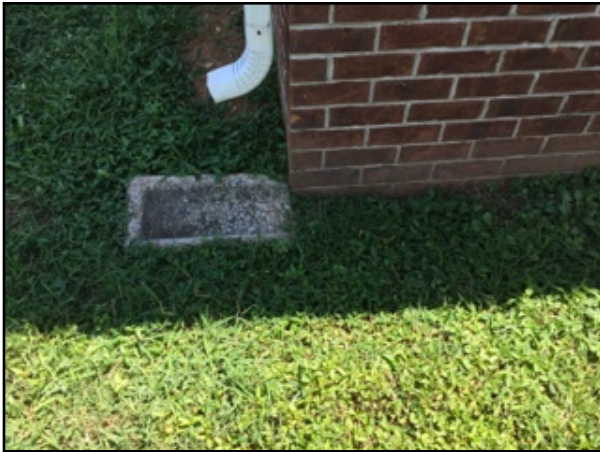
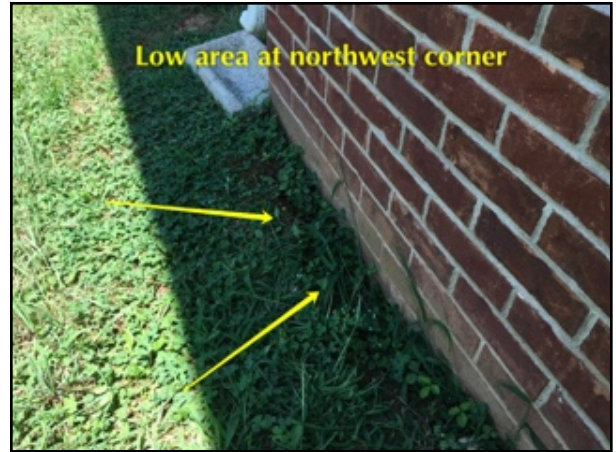
Comment 7:
 Recommend downspout extension to move water away from foundation.

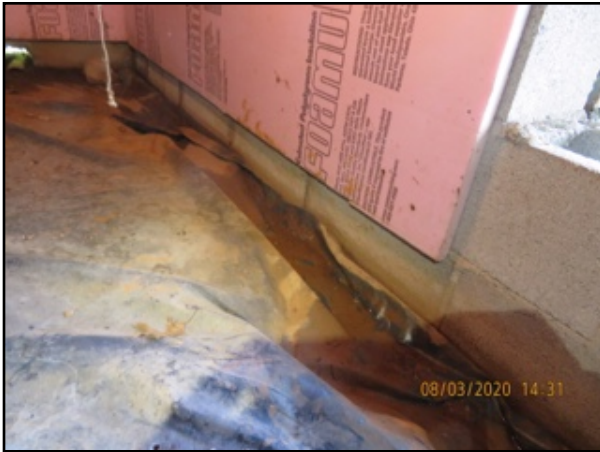
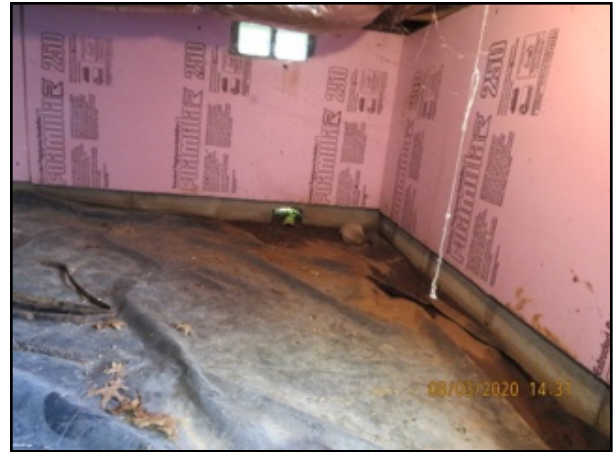
Comment 8:
Crawlspace wet at access. Pictures in "Site" will show areas here that need grade work.

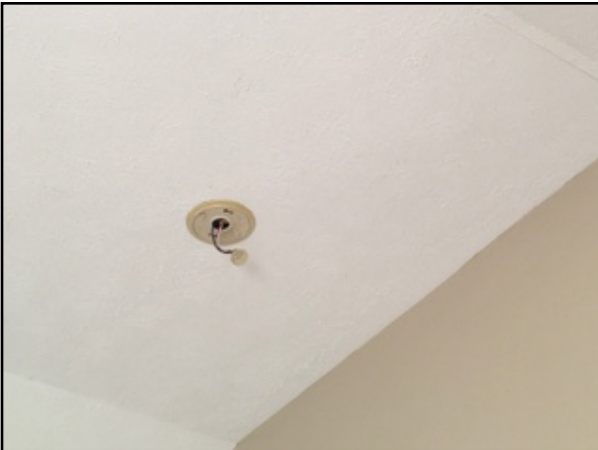
Figure 9-1

Comment 9:
Living area smoke detector missing.

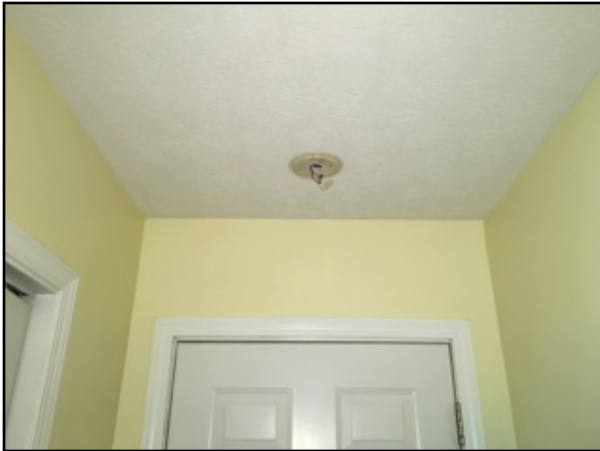
Figure 10-1

Comment 10:
Smoke detector missing in kitchen hall.

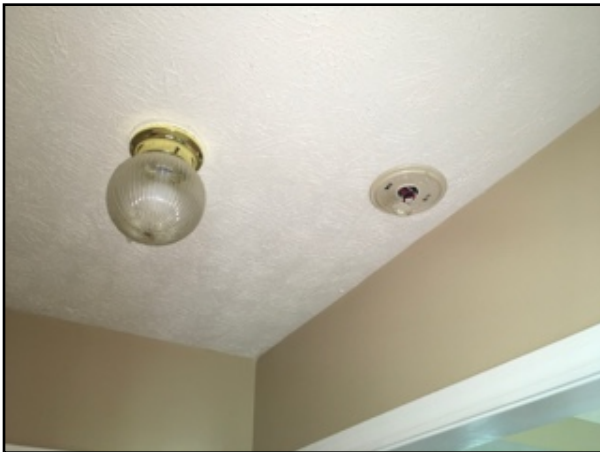
Figure 11-1

Comment 11:
Missing smoke detector hall at guest bath.

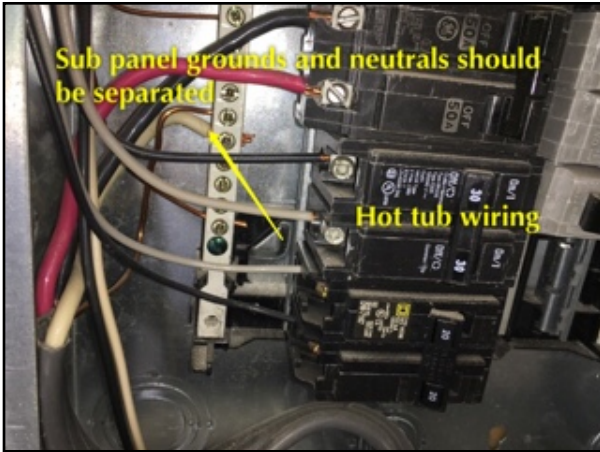
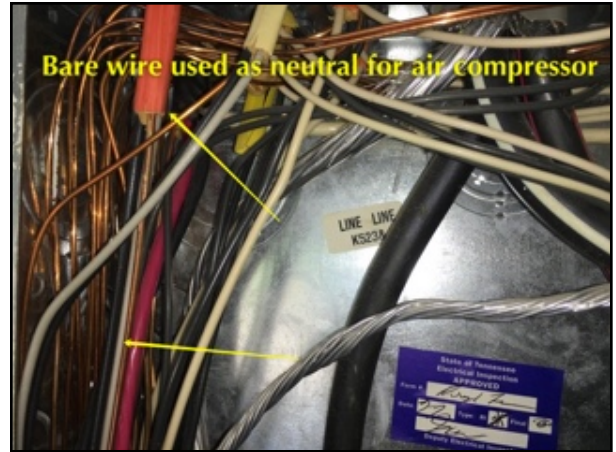
NEC calls for neutrals and grounds be isolated from one another in a sub panel.

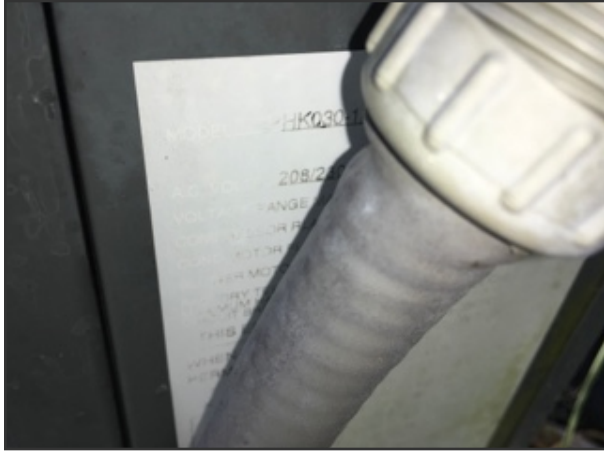
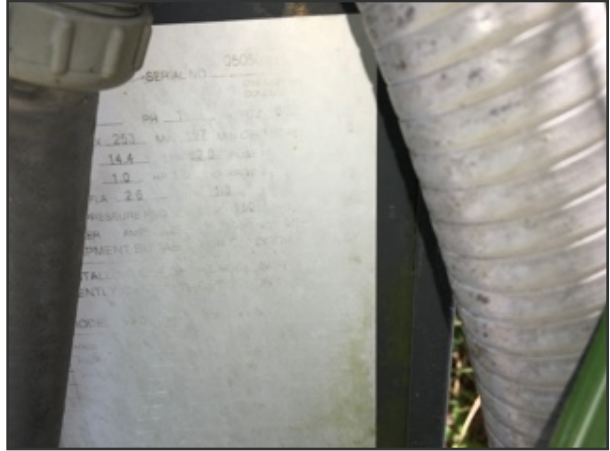
HVAC system is approaching 16 years. The average life expectancy of a unit is 10-15 years. Unit is running and cooling, however the temperature drop across the evaporator is higher than normal. Recommended to have a HVAC specialist evaluate unit for options.

Comment 15:
Average temperature drop is 15-19 degrees across evaporator.

Air conditioners over 10 years old and heat pumps over 5 years old should be checked, cleaned and serviced yearly by a licensed contractor.

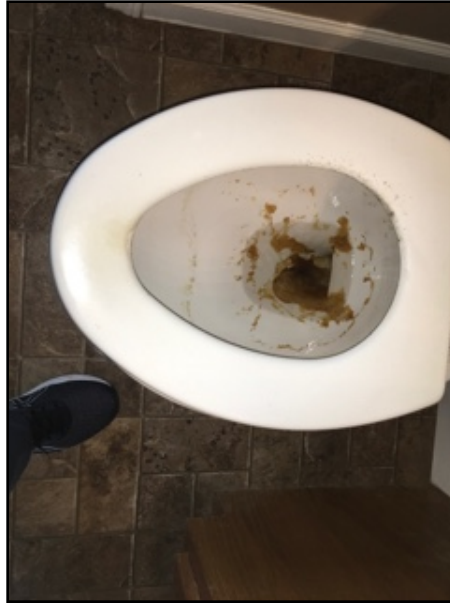
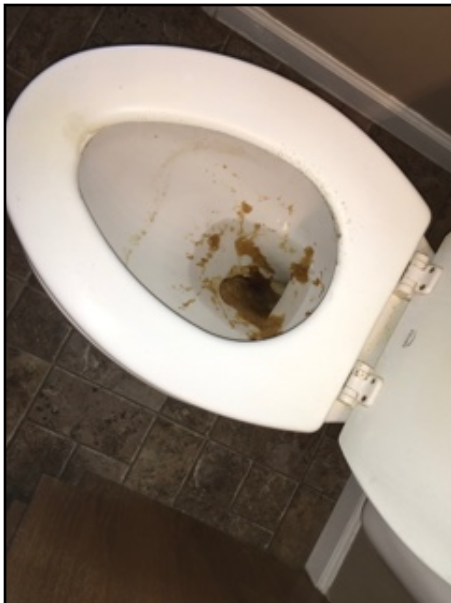
Figure 16-1

Comment 16:
Bowl stained, unsure if stains are permanent.

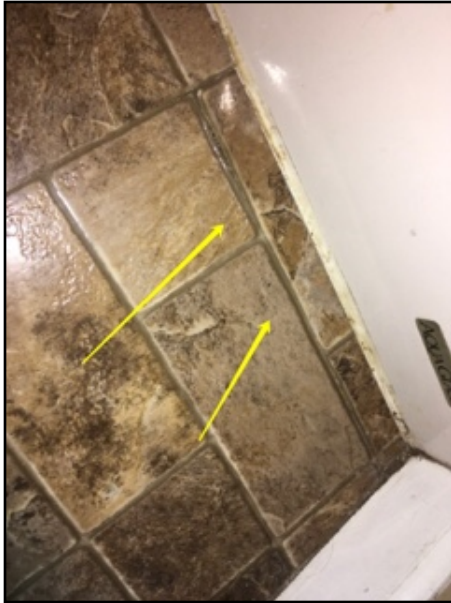
Figure 17-1

Glue seam on vinyl is loose at edge of tub.

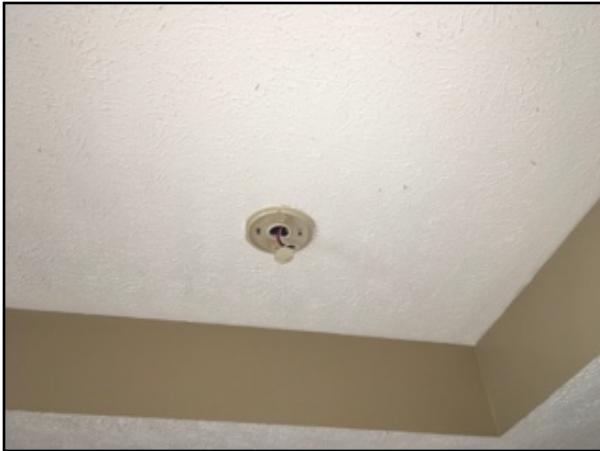
Figure 18-1

Comment 18:
Missing smoke detector.

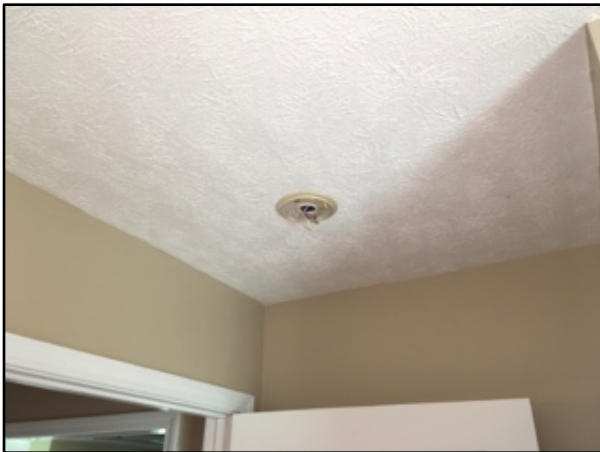
Figure 19-1

Comment 19:
Missing smoke detector .

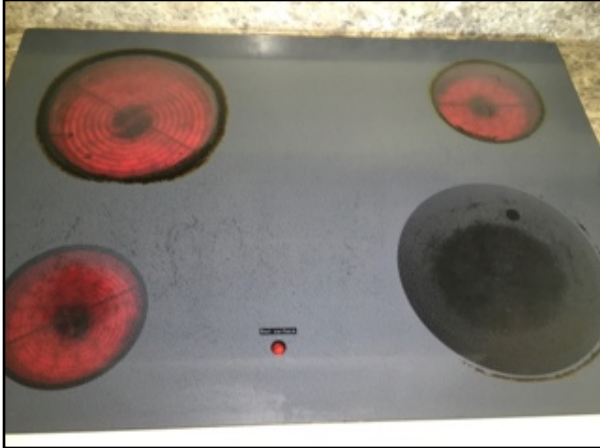
Figure 20-1

Comment 20:
Front right eye not operating on cook top.
